HISTORIC PRESERVATION PROPERTY TAX EXEMPTION APPLICATION PART I--PRECONSTRUCTION APPLICATION | With the property of the proper

A. GENERAL INFORMATION To be completed by all applicants 1, Property identification and location: Property Identification Number (from tax records): 070928 Attach legal description of property. Address of property: 152 East 4th Street City JACKSONVILLE, County: DUVAL Zip Code: 32206 ☐ Individually National Register Listed Locally designated historic property or landmark* In a National Register District In a locally designated district For applications submitted to the Division of Historical Resources, attach a copy of the local designation report for the property and the official correspondence notifying the property owner of designation. Name of historic district: Springfield For locally designated historic properties or landmarks, or properties located in locally designated historic districts, provide the following additional information: Name of local historic preservation agency/office: CITY OF JACKSONVILLE, PLANNING AND DEVELOPMENT DEPARTMENT Mailing Address: 128 EAST FORSYTH STREET City: JACKSONVILLE State: FLORIDA Zip Code: 32202 Telephone Number: (

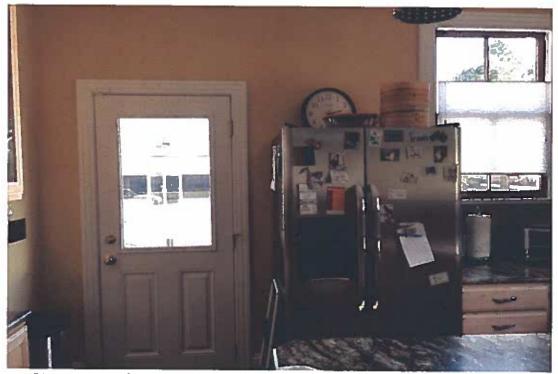
Off the shelf wood door damaged by exposure to elements

Picture 5: Kitchen Door (east side, October 27, 2015)

The door will be replaced with a special ordered wood door matching in appearance the existing front door

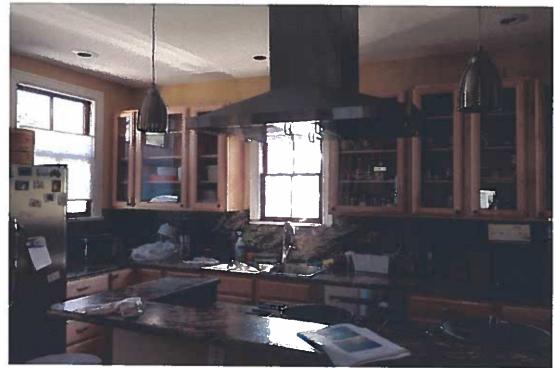
Off the shelf wooden cabinets, partially completed and

damaged. Unpainted

Picture 6: Inside Kitchen facing east. Door to outside is visible at the left side.

The cabinets will be replaced with new off the shelf cabinets and appliances.

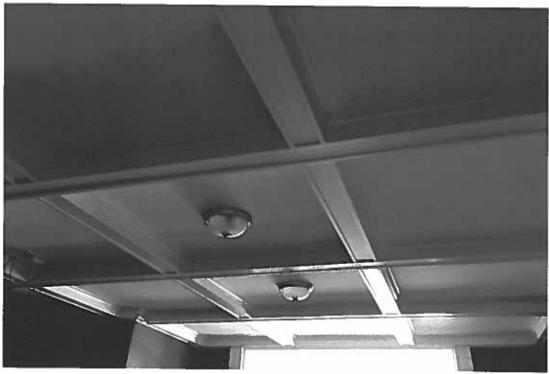
The room is gutted and a wall is inadequately supported. Photograph Number: 9,10 Drawing Number: 1,3

Picture 9: South-West room facing south

Drywall, paint and trim with style matching existing rooms.

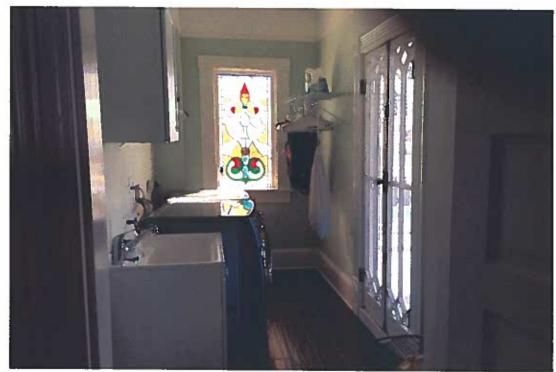
The walls are angled, probably to provide room for a closet in the south west corner after the original closet was converted to a shower.

Picture 16: Upstairs hallway facing the angled wall connecting the east bathroom and the south east bedroom.

Remove the closet at the east side of the wall per attached drawing.

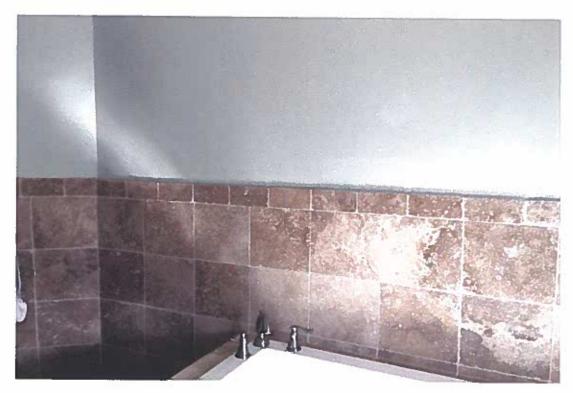
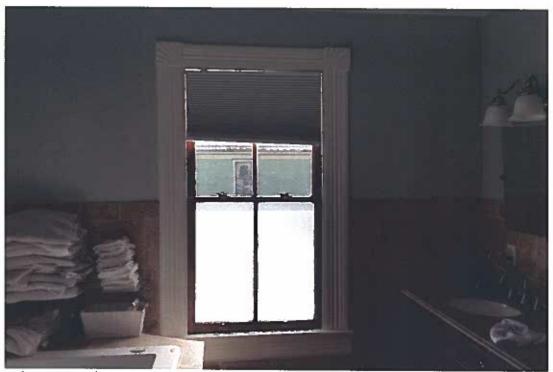
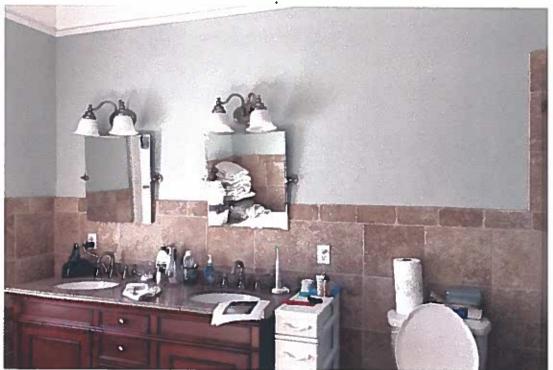
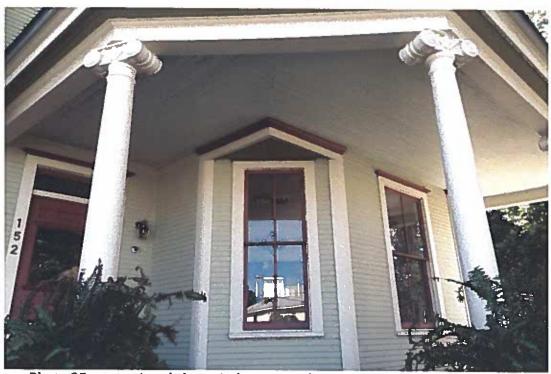
This bedroom was likely created in an earlier remodel. It has its own heat source (a wall mounted gas heater) which was Describe work and impact on existing feature:

Photo 21: 2nd Floor was South-west bedroom, now bathroom, view from outside hallway facing south-west

Photo 22: 2nd Floor was South West bedroom now bathroom. View by Facing east.

Phoot 23: 2nd Floor was South West bedroom now bathroom, view by facing south

Photo 24: 2nd Floor was South West Bedroom now bathroom, view by facing west.

remodel into bathroom per drawing. Removegas heater. Add connecting door to middle room

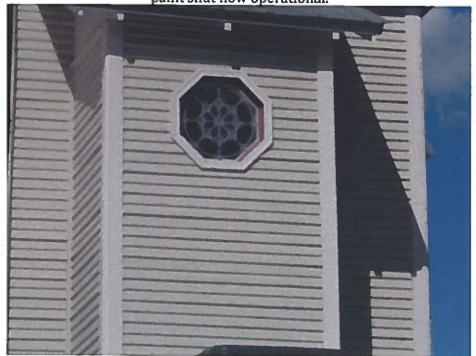
Photo 39: 2nd floor southwest bedroom window facing south. The window has been paint shut now operational.

restore all windows, replace wood-as needed. Make windows functional if possible. Paint windows and replace or repair hardware.

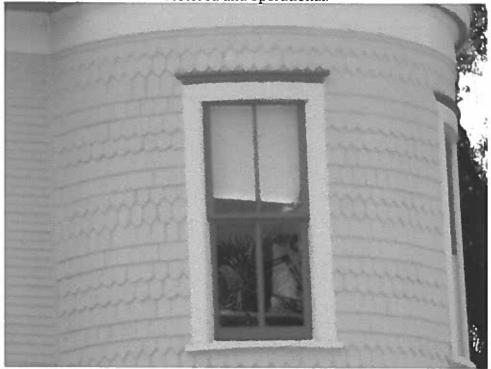
Photo 43: Window to the 2nd floor east bathroom. Glass was broken, window now restored and operational.

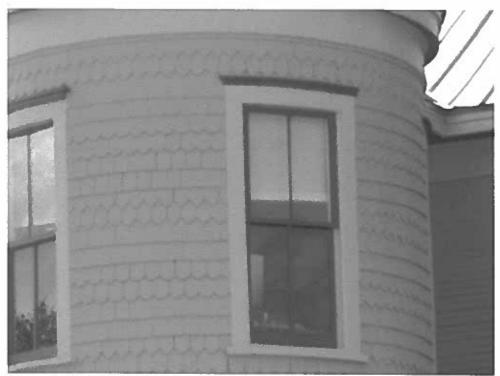
Photo 44: Window of the 2nd floor turret facing east. Panes were broken and window was paint shut. Now restored and operational.

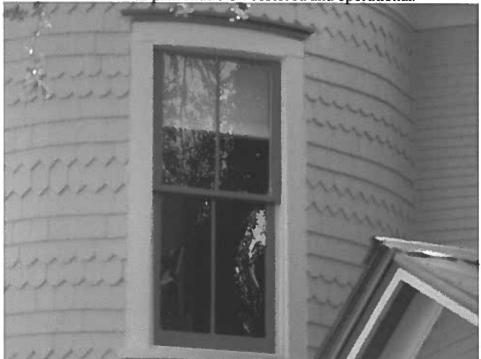
Photo 45: Window of 2nd floor turret facing northeast. Panes were broken and window was pain shut. Now restored and operational.

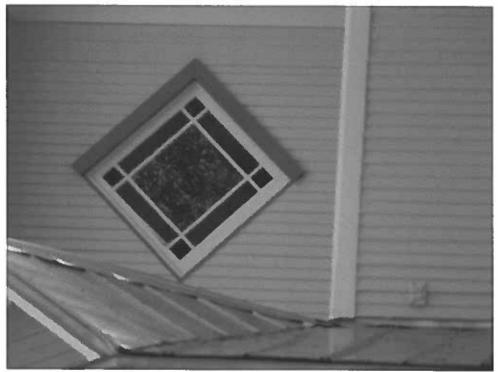
Photo 46: Window on 2nd floor of turret facing northwest. Window pane was broken and window was paint shut. Restored and operational.

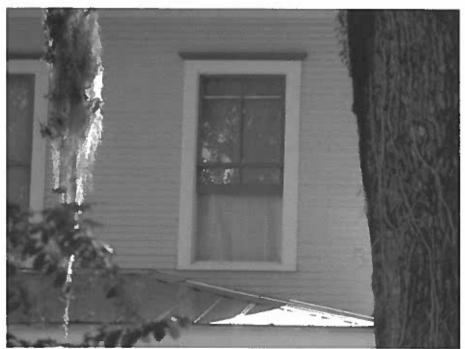
Photo 48: 2nd floor northwest room facing south. This window was partially operational but some hardware was missing. Now restored and operational (to the left of the window shown in Photo 49).

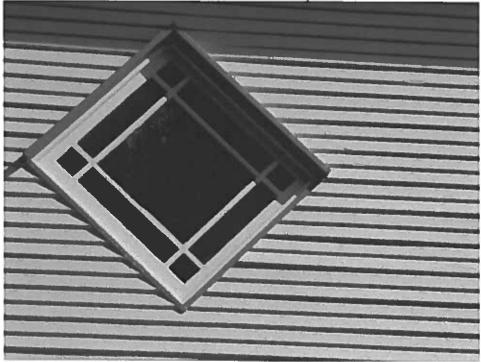
Photo 49: 2nd floor window to the northwest room facing north (to the right of the window shown in Photo 48). The window was partially operational but missing hardware. Now restored and operational.
