HISTORIC PRESERVATION PROPERTY TAX EXEMPTION APPLICATION PART I--PRECONSTRUCTION APPLICATION | With the property of the proper

A. GENERAL INFORMATION To be completed by all applicants 1, Property identification and location: Property Identification Number (from tax records): 070928 Attach legal description of property. Address of property: 152 East 4th Street City JACKSONVILLE, County: DUVAL Zip Code: 32206 ☐ Individually National Register Listed Locally designated historic property or landmark* In a National Register District In a locally designated district For applications submitted to the Division of Historical Resources, attach a copy of the local designation report for the property and the official correspondence notifying the property owner of designation. Name of historic district: Springfield For locally designated historic properties or landmarks, or properties located in locally designated historic districts, provide the following additional information: Name of local historic preservation agency/office: CITY OF JACKSONVILLE, PLANNING AND DEVELOPMENT DEPARTMENT Mailing Address: 128 EAST FORSYTH STREET City: JACKSONVILLE State: FLORIDA Zip Code: 32202 Telephone Number: (

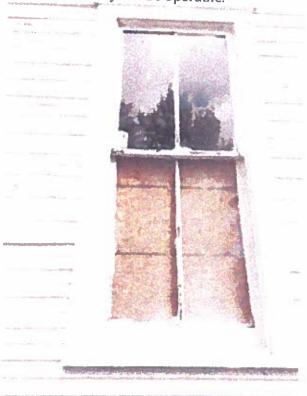
Photo 28: 1st Floor window facing west. Window may not be operable. Missing panes.

Photo 28: 1st Floor window facing west. Window restored and operational

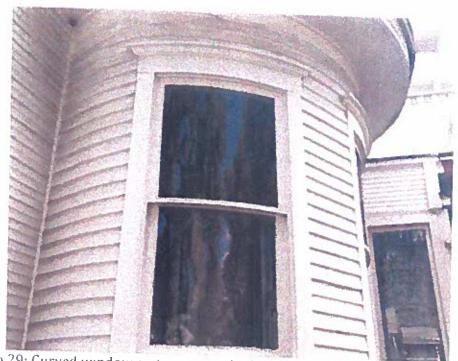
Photo 29: Curved window on turret attached to west side of house. Window faces north-west. Window is not designed to open.

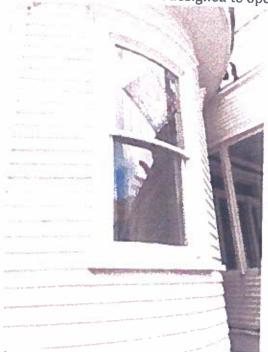
Photo 30: Curved window on west-side turret facing west. Window is paint shut not designed to open.

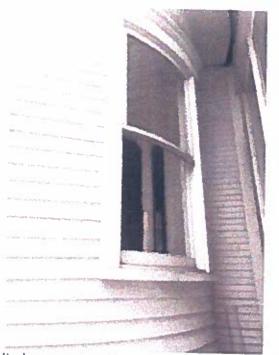
Photo 31: Curved Window on west-side turret facing south. Window is not paint shut / not designed to operate.

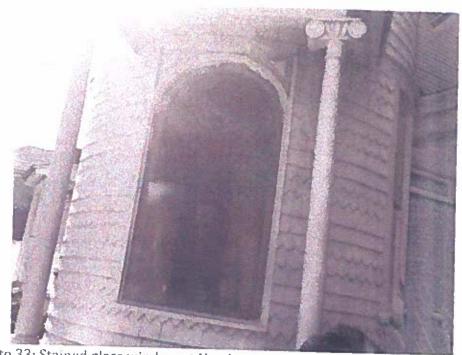
Photo 33: Stained glass window at Northeast corner of first floor. The window is protected by Plexiglas and not designed to be opened.

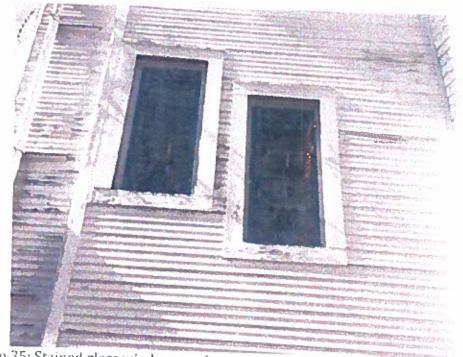
Photo 35: Stained glass windows at the east side of the house. These windows are placed at the landing of the stair case between first and second floor. The windows

Photo 35: Stained glass windows at the east side of the house. These windows are placed at the landing of the stair case between first and second floor. The windows do not open.

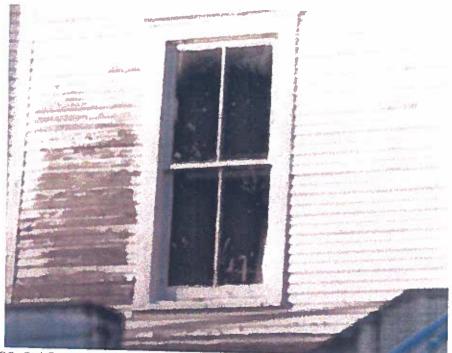
Photo 39: 2nd floor southwest bedroom window facing south. The window has been paint shut and may or may not operate.

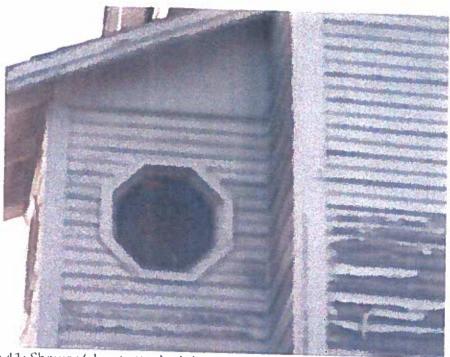
Photo 41: Shower/closet attached the south side of 2nd floor. View from the east. The window is fixed and can not be opened.

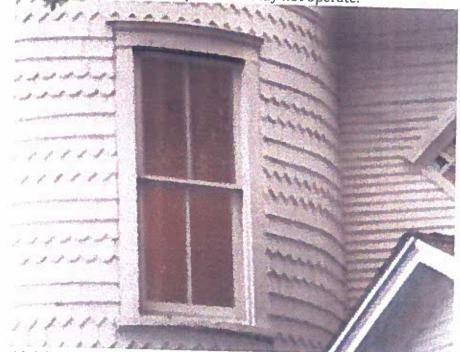
Photo 46: Window on 2nd floor of turret facing northwest. Window pane is broken and window is paint shut. It may not operate.

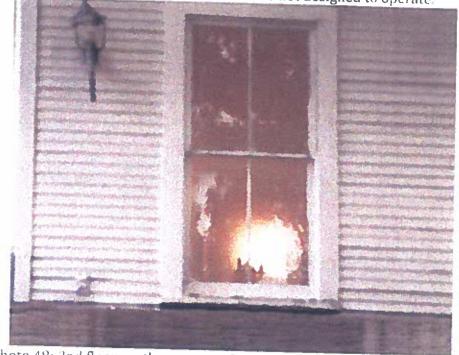
Photo 48: 2nd floor northwest room facing south. This window is partially operational but some hardware is missing. (to the left of the window shown in Photo 49).

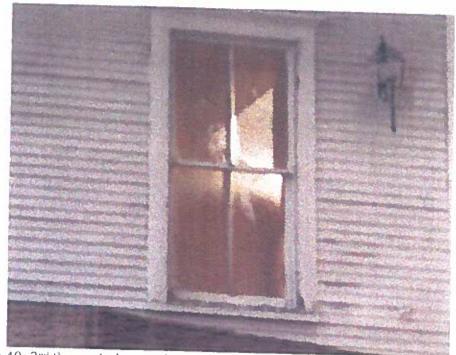
Photo 49: 2nd floor window to the northwest room facing north (to the right of the window shown in Photo 48). The window is partially operational but missing hardware.

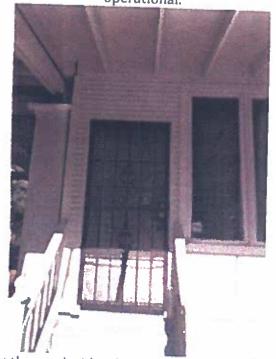
Photo 54: Backdoor at the south side of the house. The door is currently a functional off the shelf door.

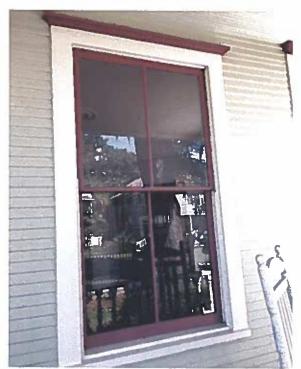
Photo 26: 1st Floor porch center window. Window faces north.

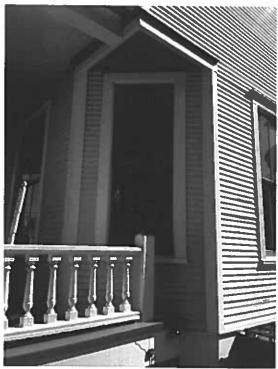
Photo 27: 1st floor window at western end of porch. Window was painted shut now restored and operational.

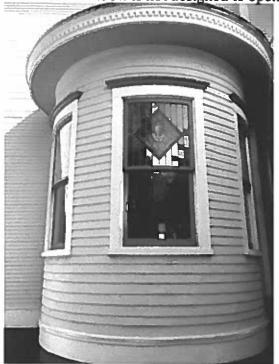
Photo 30: Curved window on west-side turret facing west. Window is paint shut not designed to open.

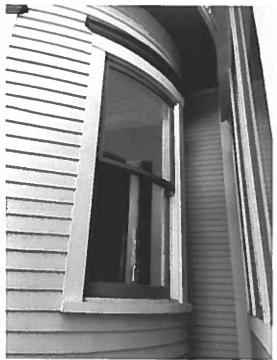
Photo 31: Curved Window on west-side turret facing south. Window is paint shut / not designed to operate.

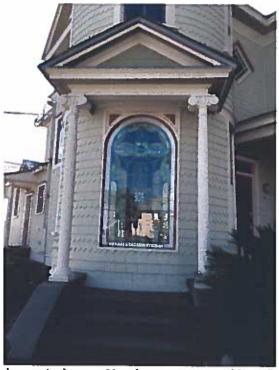
Photo 33: Stained glass window at Northeast corner of first floor. The window is protected by Plexiglas and not designed to be opened.

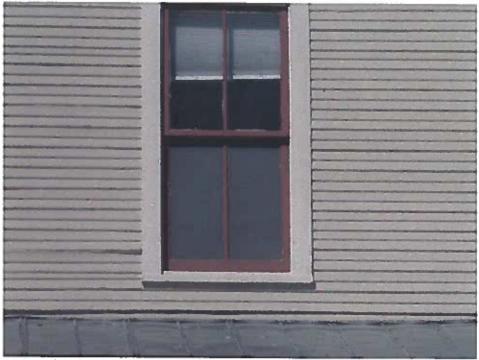
Photo 38: 1st floor kitchen window facing south. The window has been replaced but some original trim remains.

Photo 38: 1st floor kitchen window facing south.

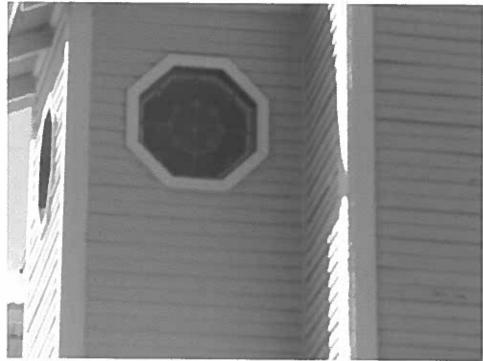
Photo 40: Shower/closet attached to south side of 2nd floor. The windows are fixed and can not be opened.

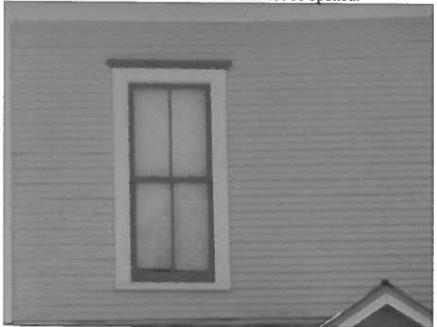
Photo 41: Shower/closet attached the south side of 2nd floor. View from the east. The window is fixed and can not be opened.

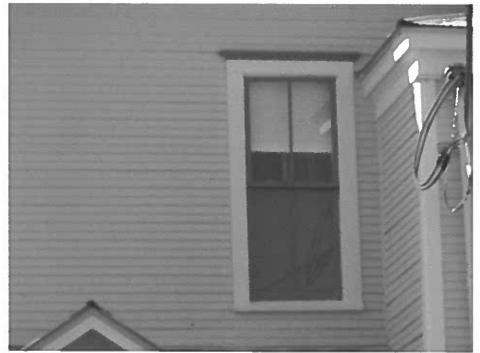
Photo 42: East facing window to the 2nd floor southeast bedroom.

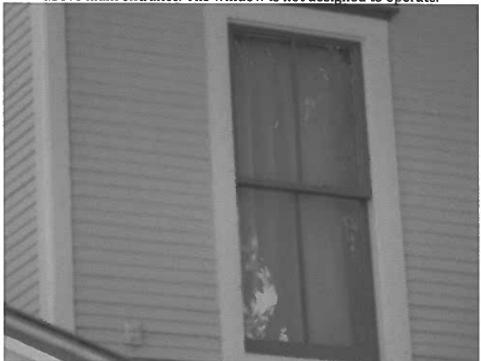
Photo 47: 2nd floor diamond shape window facing north right next to the turret above main entrance. The window is not designed to operate.

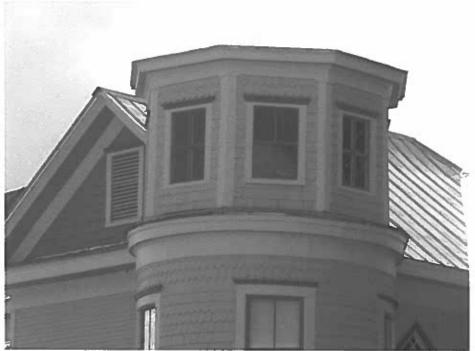
Photo 52: 2nd floor round window to the middle room. This window is not designed to be opened.
